**Contract No:** 306-C-00-11-00506-00  
**USAID Project Title:** Kandahar Helmand Power Project (KHPP)  
**Document Title:** Assessment Report  
Kajaki Dam Unit 2 Hydro Inventory and Condition  
**Author(s):** John (Jack) Whippen  
**Contractor:** Black & Veatch Special Projects Corp.  
**USAID Agency:** USAID Office of Infrastructure, Energy, and  
Engineering - Afghanistan  
COR: Massoud Orya  
**Date of Publication:** February 5, 2014  
**Language:** English

## **Kandahar Helmand Power Project (KHPP)**

Kajaki Dam Unit 2 Hydro Inventory and Condition  
Assessment Report – FINAL  
January 31, 2012

**AMENDED 5 FEBRUARY 2014**

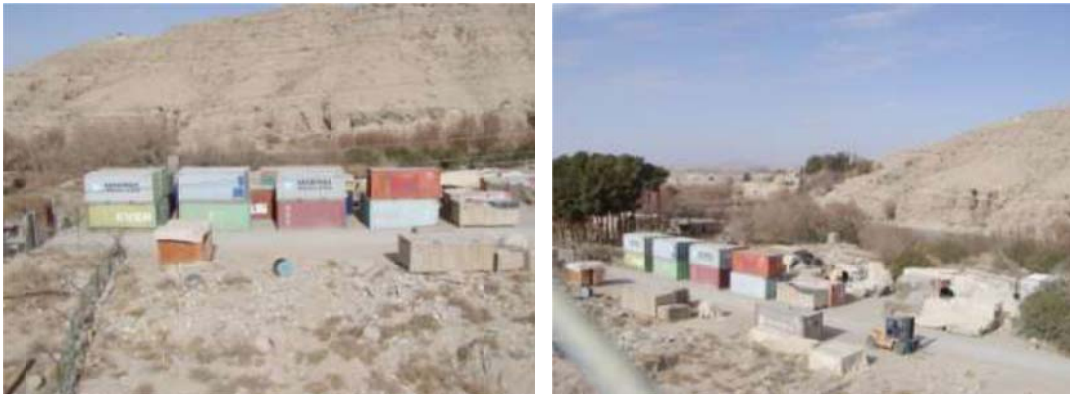
Original view of laydown area showing limited space between container ends.

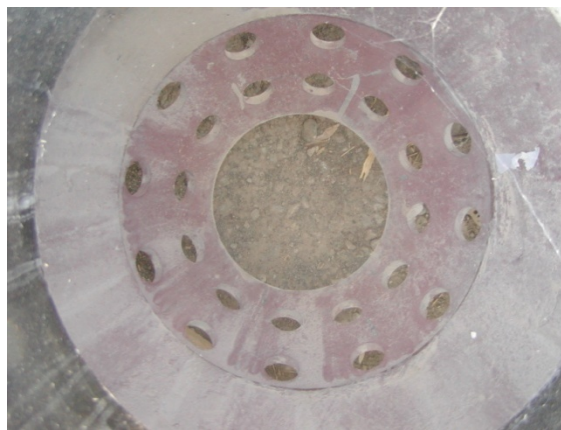
Runner Nose Cone vent holes as seen from top.

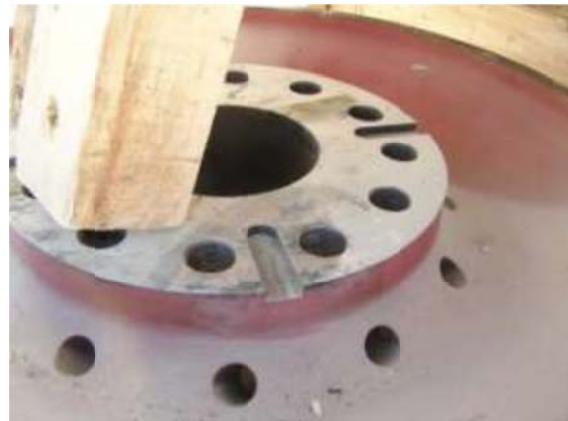
The runner is a martensitic stainless steel and has some minor areas of corrosion present. There are notations for matching the turbine shaft to the runner. A new turbine shaft was supplied with the new generator shaft. The runner/turbine shaft match is fixed with flat keys at 90°.

Runner hub showing flat keys at 90°

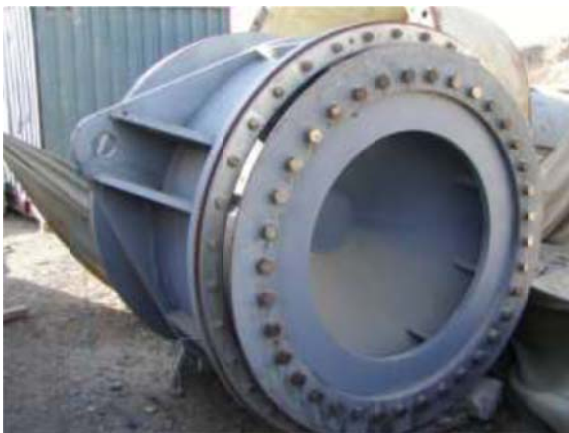
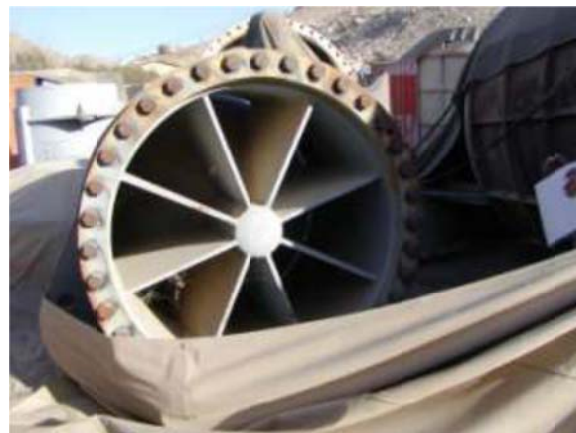
The Relief Valve components are in good condition with no physical damage and with only general deterioration of the paint noted. The martenistic stainless steel valve seat has some observed staining. The slide cylinder will require lubrication upon installation.

Inlet end of the valve

Outlet end of the valve

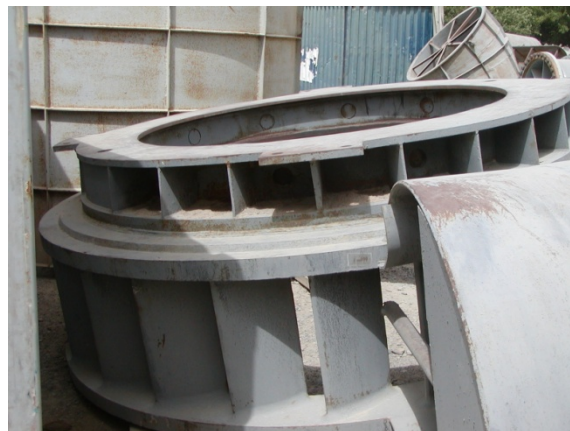
The bottom surface of the scroll case which rests on the adjustable embedded sole plates appears to the naked eye to be warped. If this warpage extends to the ring fit for the lower ring, on-site machining may be required to properly fit the lower ring or to correct the warped plate prior to embedment.

Spiral Case situated upside down. Note apparent warpage of the top (bottom when in use) plate.

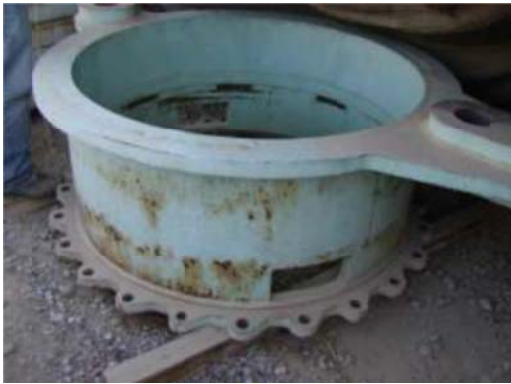
Operating Ring with self-lubricating bushings installed.

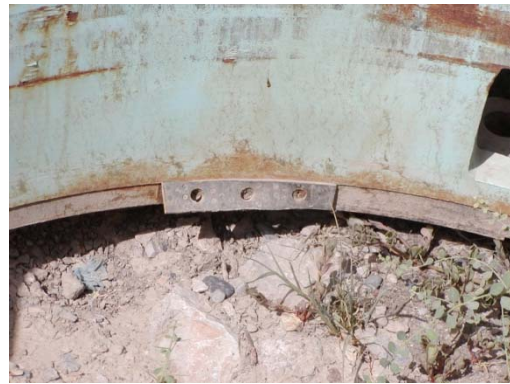
The operating ring is intact with the exception on one damaged anti-friction pad. The pad appears to have caught on some cribbing and torn loose from its mounting screws. The pad seems to be beyond repair and must be replaced. Installation of a new pad is superficial. As can be seen, this component will require clean up and re-painting. The installed self-lubricating bushings will require clean up as well.

Damaged anti-friction pad at bottom ring.

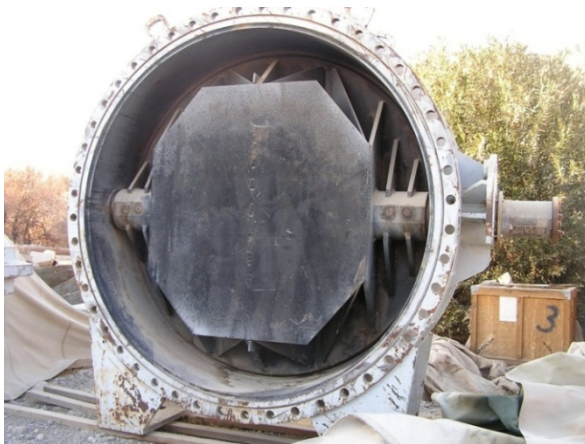
Both of the cylinders welded to the gussets have cracks adjacent to the stiffener plate. These are not critical structural connections and can be repaired on site. Cracking was probably due to excess heat applied during construction welding with no provision for thermal contraction during cooling. A field repair should incorporate grinding a “Vee” for the length of the crack and two short weld passes for that length with cooling between passes. Cover passes should duplicate that process until the groove is filled. Emphasis should be on penetration into the cylinder rather than the side gusset plate. The additional ties to the leaf are sufficient to provide support to what is essentially a spacer on the leaf shaft. Cracking was found on both sides as well as the back side of the cylinder shown on the left side. The back side cracking is not accessible for repair.

Upstream view of Inlet Valve

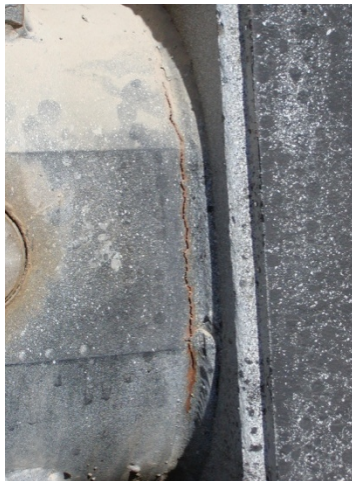
Close-up of crack

9. Unit 2 Inlet Valve cracks were found, as identified by USAID, but are not structural in nature and can be repaired on site.
10. All exposed metal surfaces will require cleaning and refinishing.

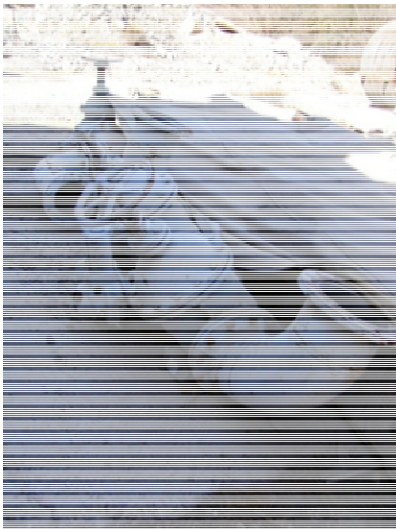
The motor operator on the motor operated bypass valve and a hand-wheel operated guard valve on the inlet valve by-pass have been damaged and will require replacement. The manual valve stem is bent and the handwheel is broken as well.

Broken motor operator on the Main Inlet Valve bypass

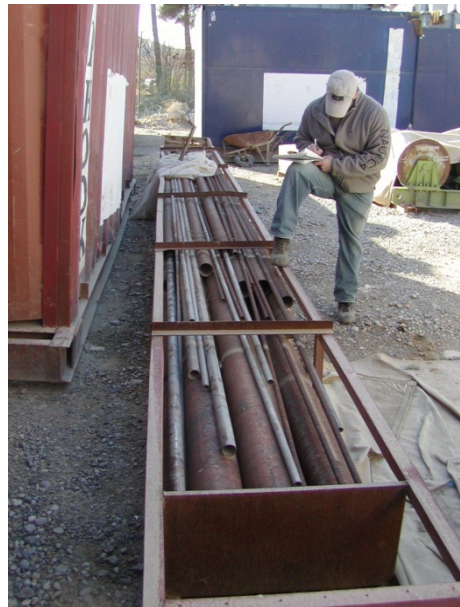
Several bundles of various sizes of standard pipe intended for air, water and oil systems are included in mostly exposed racks. This should cause minimal problems because all of the piping that is exposed will require cleaning prior to painting.

Typical assortment of standard and stainless steel pipe.

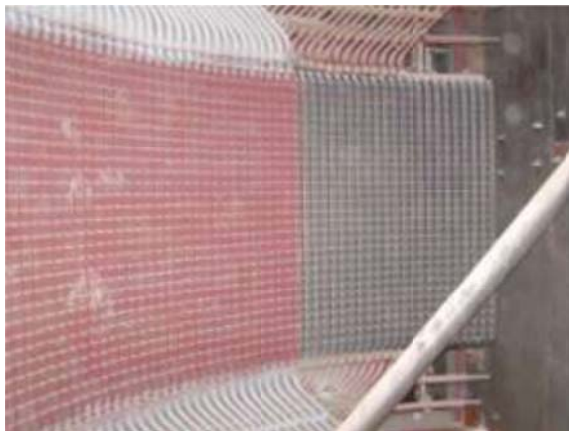
View of stator portion from within the bore area.

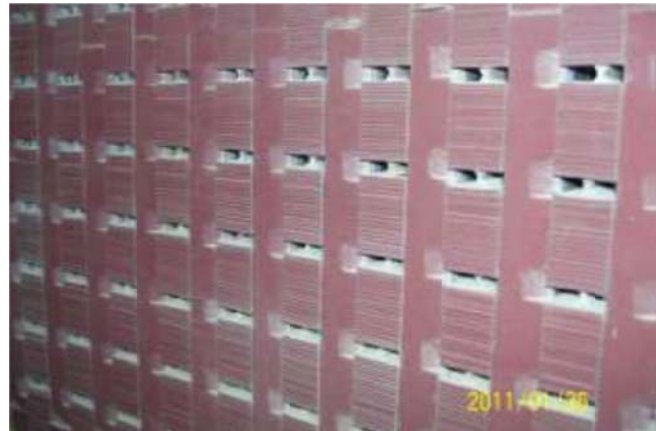
Close-up of stator bore and slot wedges.

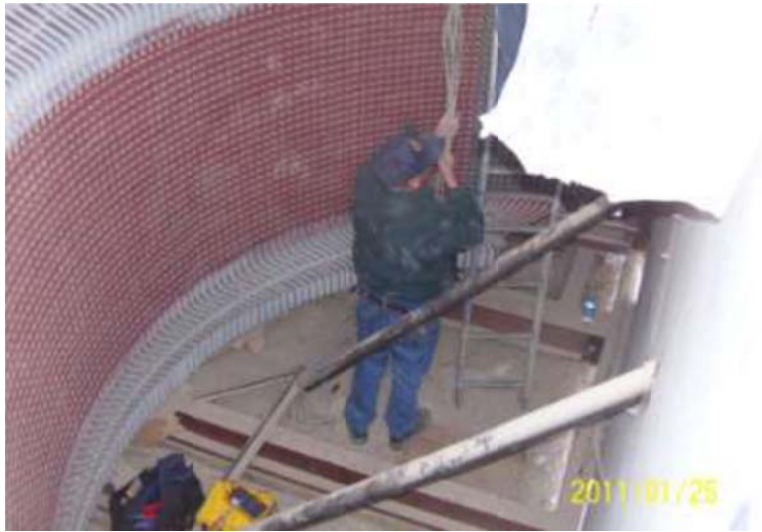
The 24 RTD cables were left casually bundled at the top of the stator core. None of the cables were labeled or otherwise marked as to location or function. Some difficulty will be encountered during installation in identifying the RTD locations.

Preparing stator RTD's for testing.

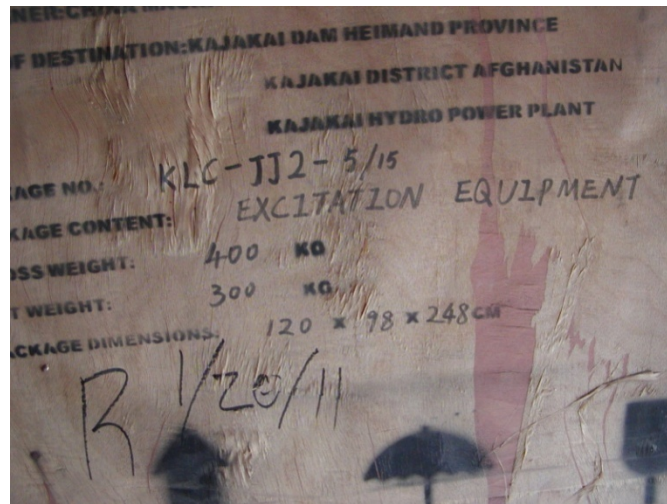
Typical Excitation Equipment crate markings. Note weathering although an umbrella indicates indoor storage.

There was evidence of water intrusion into one crate and onto the panel door although the water did not appear to have entered the cabinet interior.

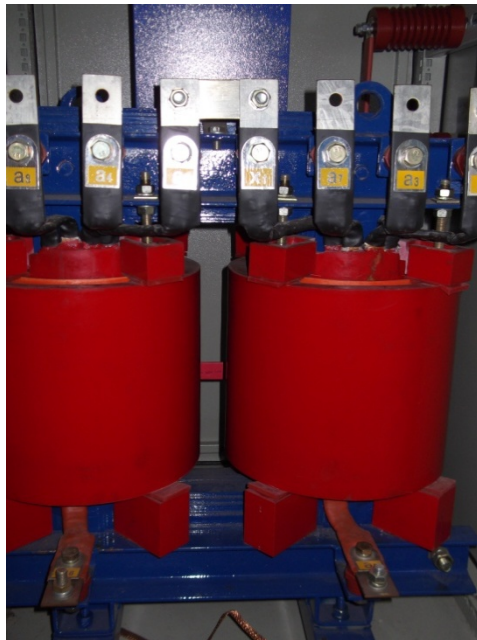
The neutral grounding equipment cubicle is contained in a single shipping crate. The crate was opened and the contents inspected. All contents were in good condition. There was no evidence of physical damage to the grounding transformer or the resistor bank.

Generator neutral grounding transformer.

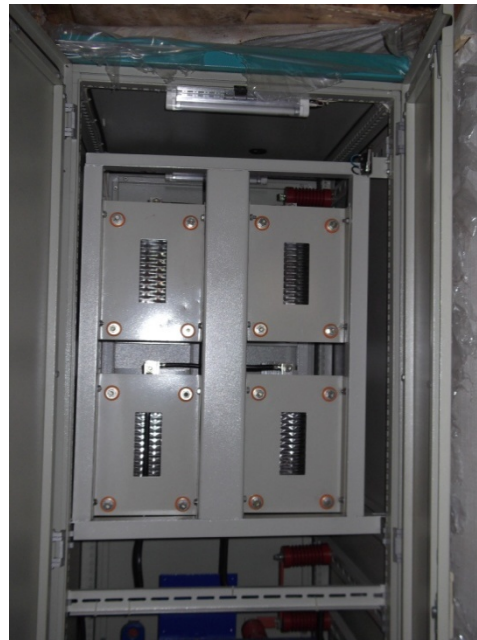
Resistor bank, disconnect links below.

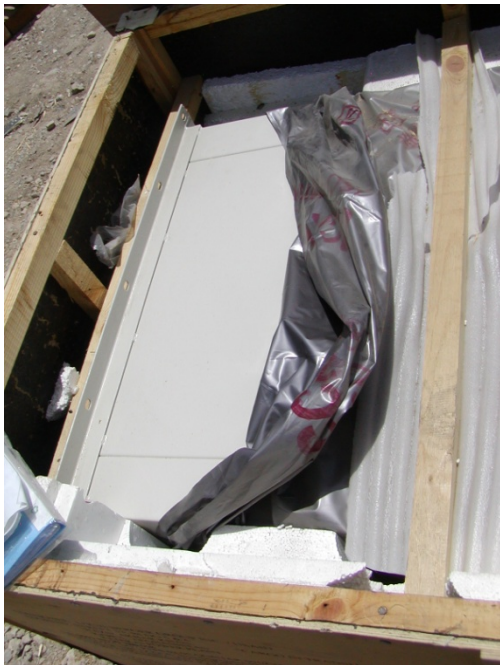
The bus duct sections were packaged separately in 9 crates. Included with the bus duct sections are hardware and stand-off insulators. There are straight, elbow and expansion sections in the array. Also included in separate crating are the bus segments with connecting hardware. All duct sections and the bus bar are in good condition.

Section of bus duct.

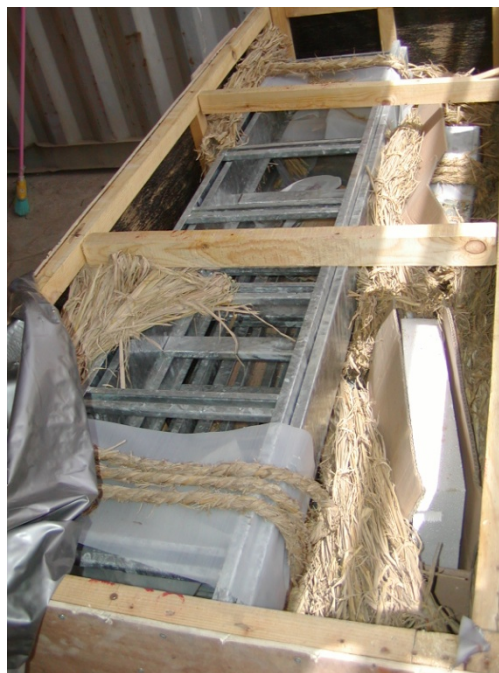
Various sections of ladder-type cable tray are also provided. The cable trays are constructed of galvanized steel. All were found to be in good condition.

Galvanized ladder-type cable tray.

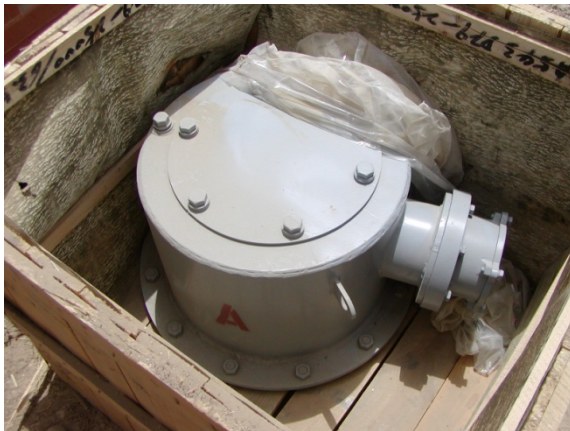
The only damage to any of these components was some minor paint damage to the radiators due to rubbing during shipment, slight paint rub on all conservator vent pipe flanges, and one CT's vent pipe slightly bent.

HV CT Assembly

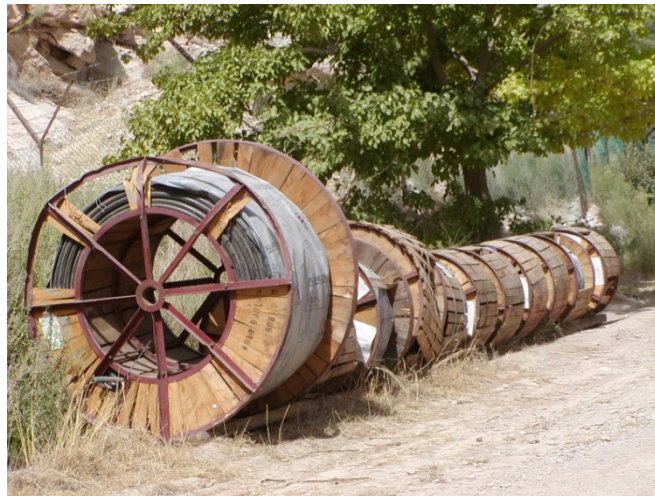
There were 13 reels of cable inventoried of various conductor sizes and lengths. Data was added to the GFE spreadsheet to indicate the size, voltage class and length of the supplied cables. Some of the reels were damaged, the cables were dirty and dusty and it has been assumed they may be adequate. Testing cable required use of high voltage test apparatus, which the assessment team could not bring to site. Further, testing unshielded or cable on a reel is not recommended. Testing can be done once the cable is installed. However, due to potential schedule delay during construction, if the cable is determined to be damaged and require replacement and inability to get replacement cables in a timely manner KHPP has assumed replacement of these cables. Data was added to the GFE spreadsheet to identify those reels with damage. There were two "rolls" of cable identified on the GFE only as DL TJ3 that were not located.

Line-up of cable reels of various sizes and voltages.

KHPP has procured and delivered to Kajaki HPP replacement cable.

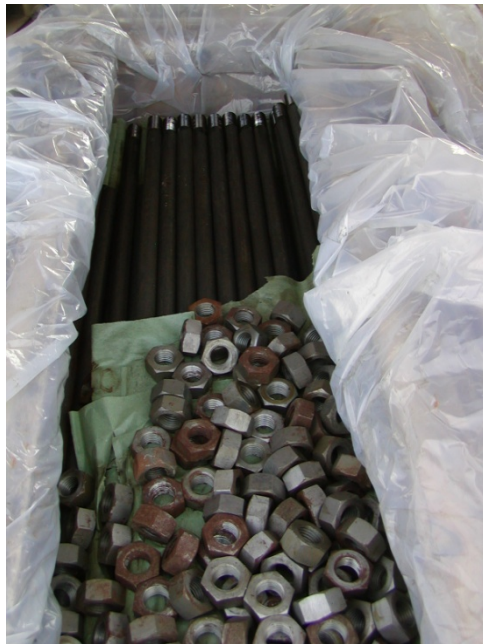
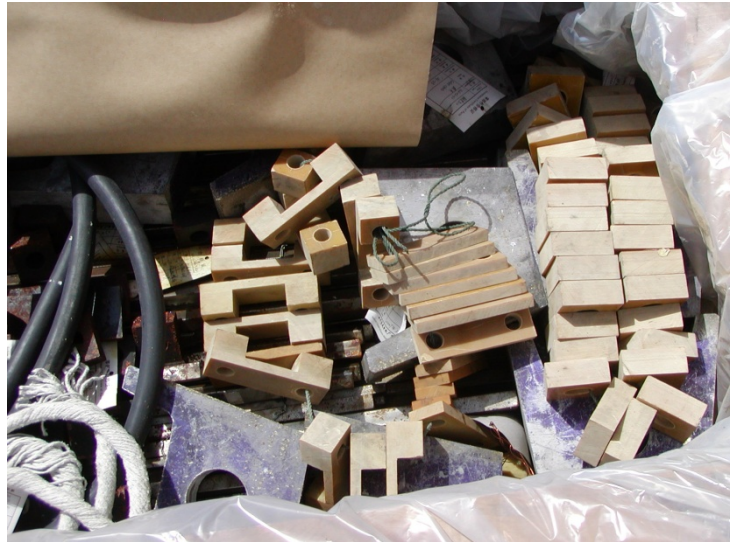
Examples of how hardware and accessories were shipped.

Loose materials consist of piping, nuts and bolts, cans, drums, etc. with insufficient labeling or other forms of identification to indicate its function or use. Some of these materials are stored in the “at large” areas and others are in containers. Still others were in wooden crates with no detailed packing list attached.

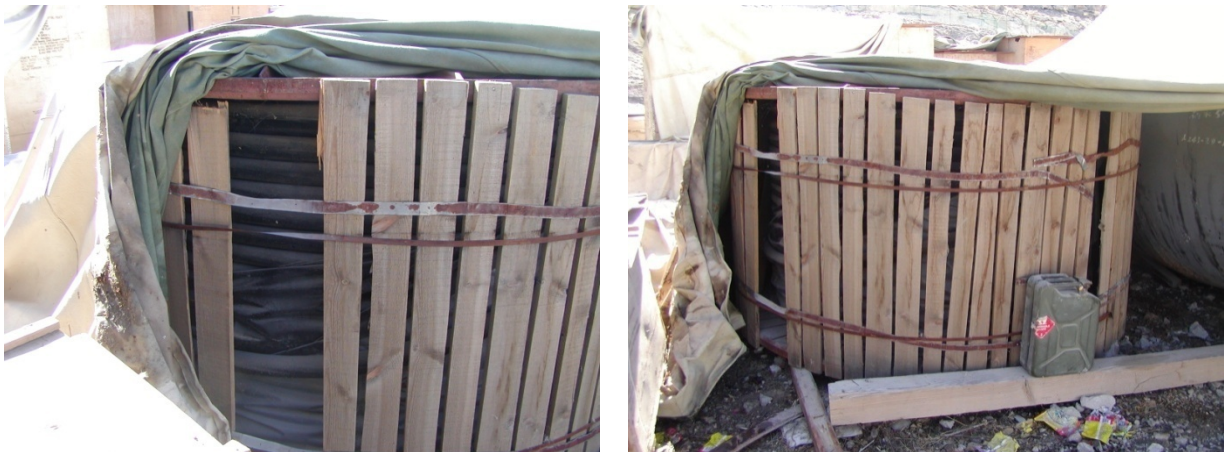
**Large reel of cable: 400 m, 450/750 v., 4/c 4@ 1.5 mm<sup>2</sup>**

KHPP has procured and delivered to Kajaki HPP replacement cable.

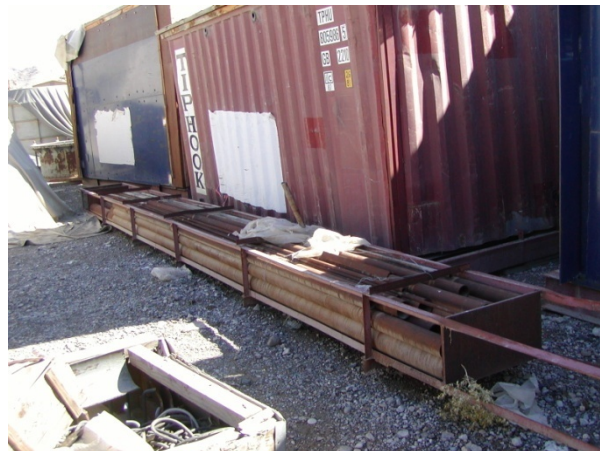
Another piping inventory bundled in a steel crate. Some of this pipe is SS.

KHPP incorporated replacement of miscellaneous piping in the Unit 2 Installation subcontract package scope.

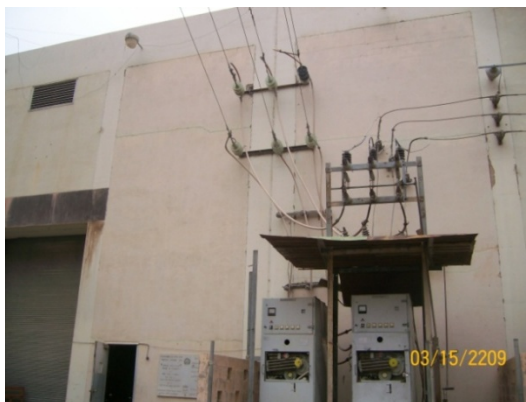
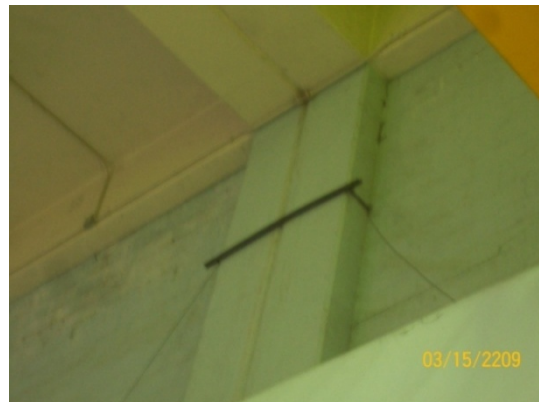
The upper power lines are held in place with angle iron that has been fastened around one of the building's concrete columns.

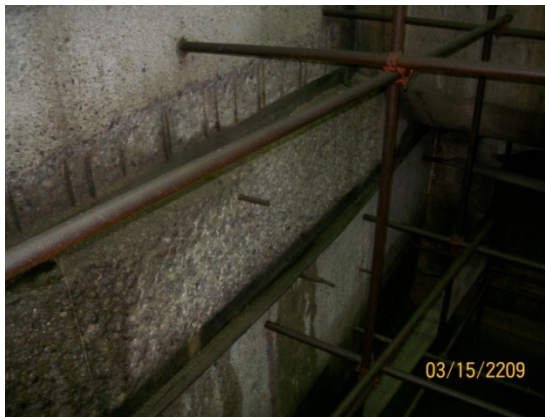
On level 4 (lowest level) it appears that the existing concrete has been abraded with a light chisel of sorts to roughen the concrete for future bonding of the concrete for the installation of Unit 2. Not all of the existing concrete surfaces adjacent to Unit 2 have been abraded or roughened. Also visible is a water stop that is embedded in the concrete.

The concrete has been roughened in preparation for placing of concrete for unit # 2.

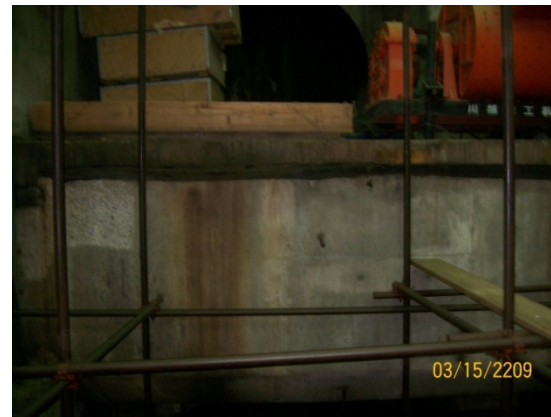
Not all of the concrete has been roughened.

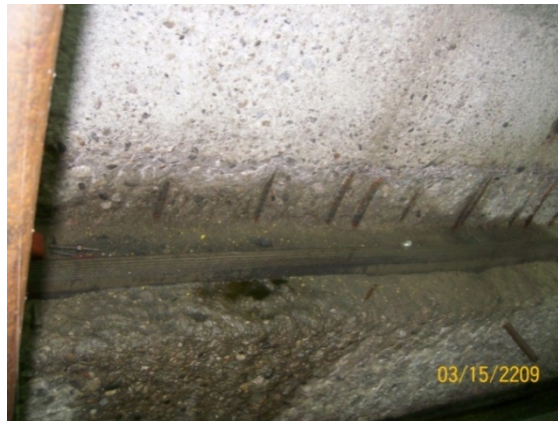
Water stops have been embedded in existing concrete.

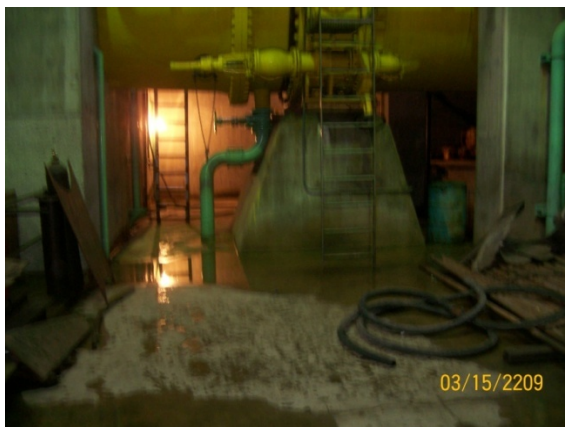
A large poured in place concrete block is used to support the inlet butterfly valve on the lowest level in the power house. A smaller poured in place block is used to support the hydraulic servo that controls the valve. The servo sole plate has not been grouted. It also appears that some of the bolts to the servo were broken and a coupler was used to fasten them back together.

Large poured in place concrete block.

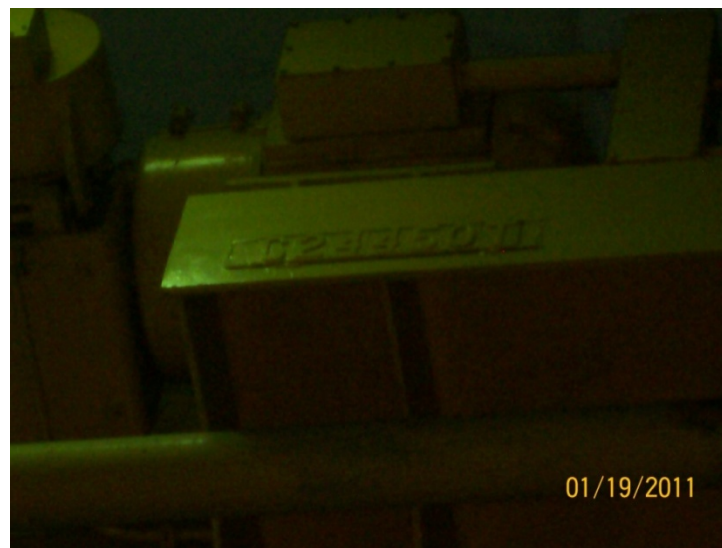
The serial number on the crane was found in two locations. One is cast into the trolley and the other was found on the information plate located near the operator's chair. The serial number is C24450T and can be seen in the photo below:

Crane serial number C2440T noted on trolley.

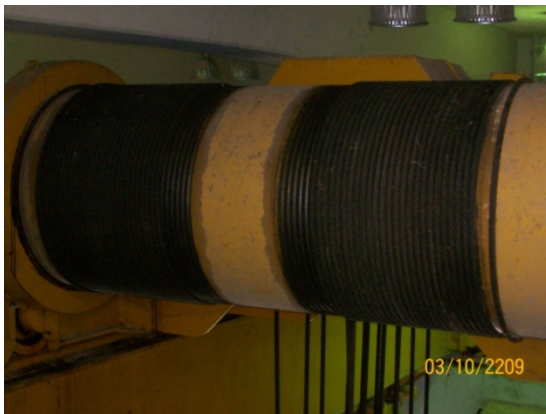
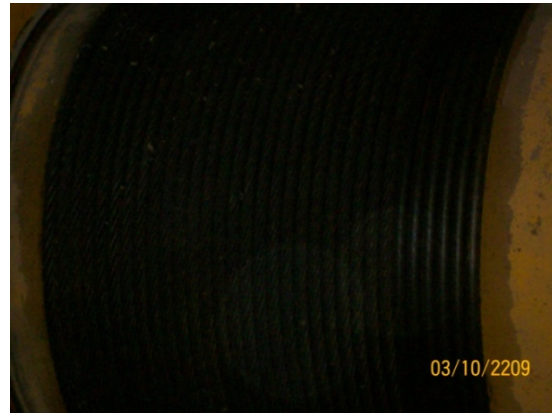
It appears that the crane cable has been well maintained. It appeared to be adequately lubricated.

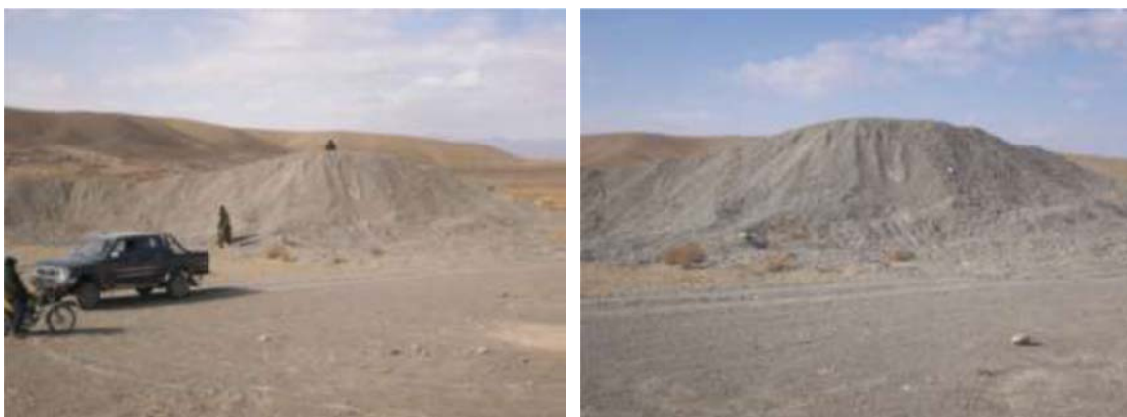
Three samples were taken from three different stockpiles of aggregate. All three sources appeared to have been taken from the river bed as it appeared to be mostly smooth, well rounded, river-washed rock. The aggregate size ranges from approximately 2 to 4-inch in size. The samples were submitted to a testing laboratory to determine if the material is suitable for use in the construction activities for Unit 2. The total volume of all stockpiles is approximately 4,900 cubic meters. Test results indicate the aggregate is acceptable for concrete use and is not reactive. Test results are presented in Appendix 15.

These photos are of the first stockpile from where samples were obtained (approximate volume is 858 cubic meters.)

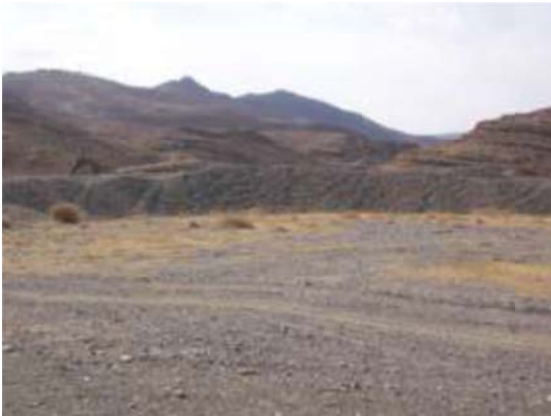
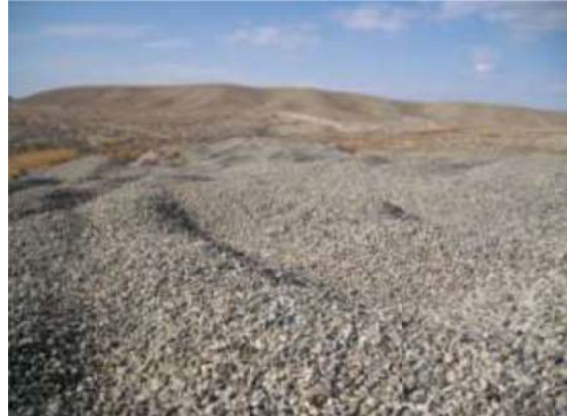
These 2 photos are of the second stockpile from where samples were taken (approximate volume is 2,420 cubic meters.)

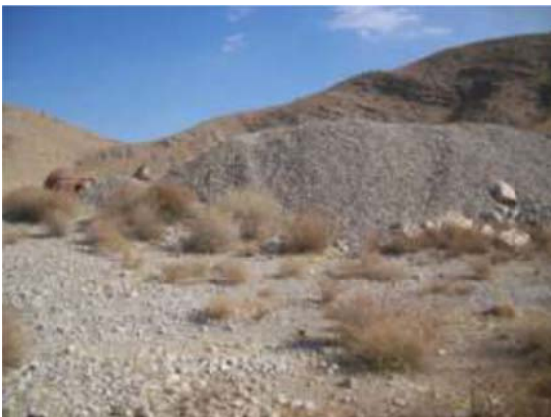
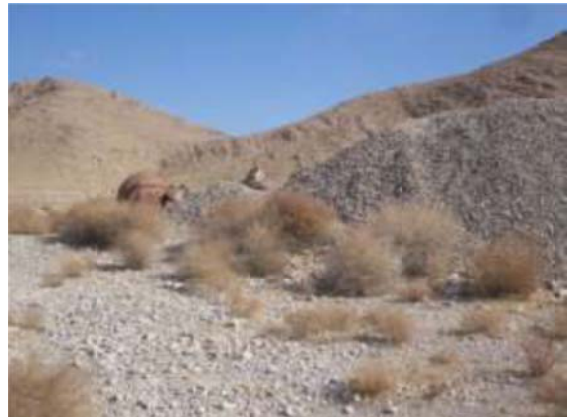
These 2 photos are of the third stockpile that samples were taken from. This stockpile is nearest to the batch plant (approximate volume is 1,625 cubic meters.)
